**TSCA PCB INSPECTION
SPOKANE SCHOOL DISTRICT
GLOVER MIDDLE SCHOOL
SPOKANE, WASHINGTON**

FACILITY: Glover Middle School
2404 West Longfellow Avenue
Spokane, Washington 99005-1547

DATE OF INSPECTION: March 15, 2000

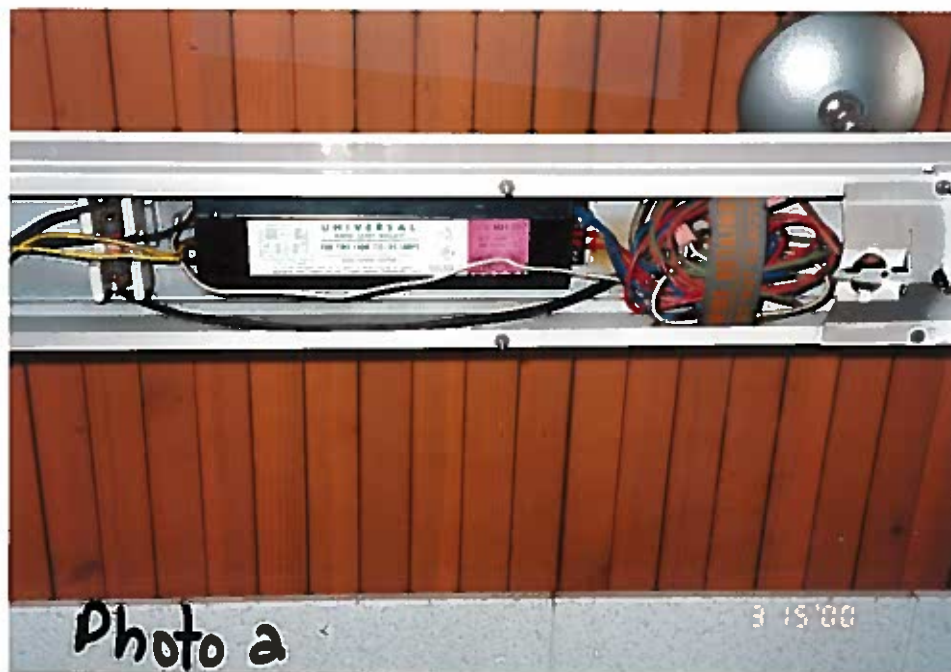
McCartney had no safety glasses. The ballast capacitor within the fluorescent fixture was manufactured by Universal, 227 Volt, 60 hertz. There was no indication on the nameplate as to PCB content (photograph 2), nor was the date of manufacture noted. Photograph 3 shows the interior of the ballast cover and shows the tar like substance on the internal surfaces of the light cover. Photograph 4 shows the tar-like substance on the interior of the light cover. Mr. Miller was observing us and I showed him what we had found. We placed traffic cones in the area until the cover could be replaced. The janitor also placed a type of dolly in the center to prevent children and staff from walking around the cones and beneath the leaking fixture. Mr. McCartney removed and double-bagged the gloves he had used to handle the light.

Photograph 2 taken by Eileen Hileman on March 15, 2000, at Glover Middle School, Spokane, Washington. Photograph 2 shows ballast capacitor in the light fixture in the main hallway front entrance. The ballast capacitor was manufactured by Universal, 227 Volt, 60 hertz. There was no indication on the nameplate as to PCB content.

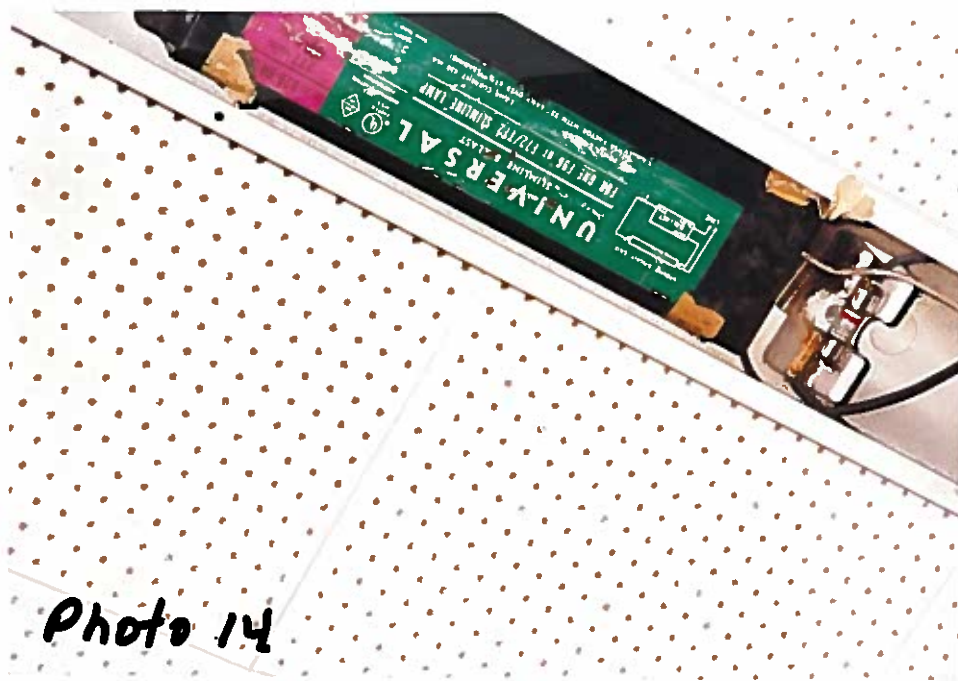
Photograph 14 taken by Eileen Hileman on March 15, 2000, at Glover Middle School, Spokane, Washington. Photograph 14 shows the Universal ballast capacitor with a tar like substance to the right side of the capacitor in the main hallway, next to Room 127. There is no indication on the nameplate as to the PCB content in the capacitor, nor is a date of manufacture listed on the nameplate.

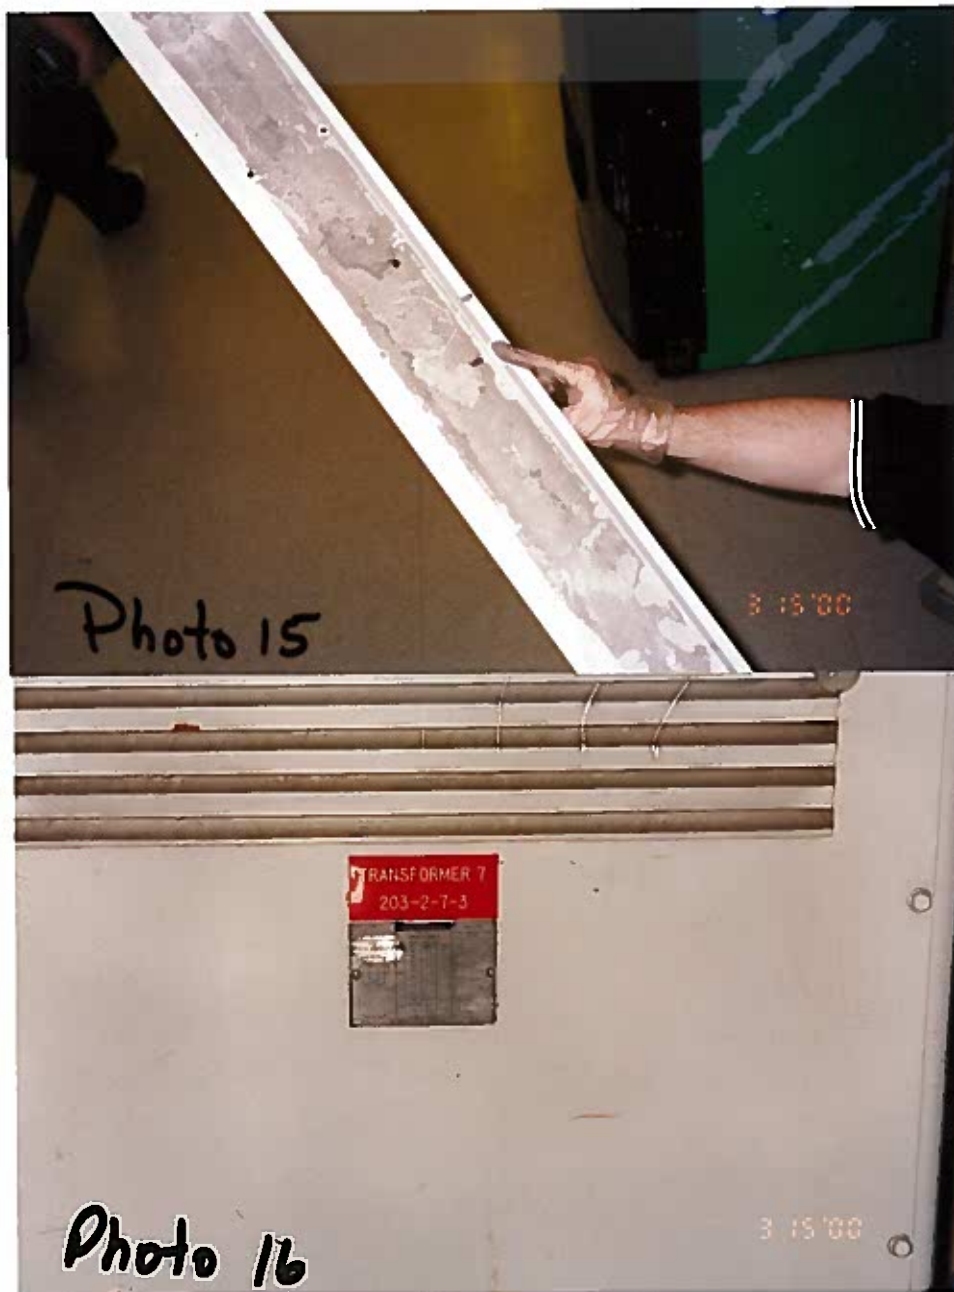
Photograph 15 taken by Eileen Hileman on March 15, 2000, at Glover Middle School, Spokane, Washington. Photograph 15 shows the internal surface of the ballast cover of the fluorescent light fixture in the main hallway next to Room 127..

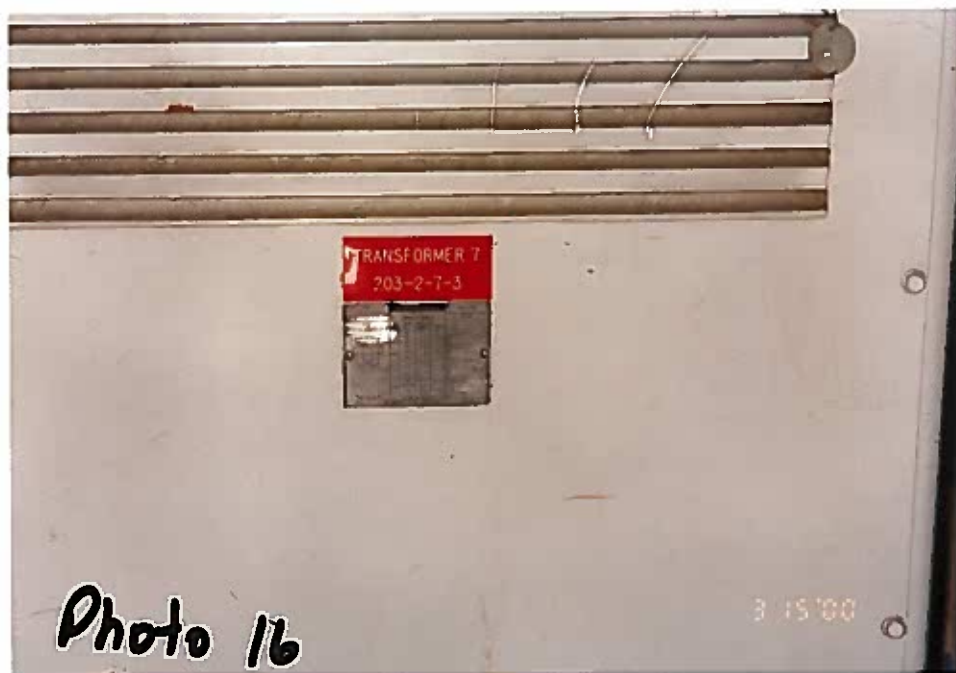
Photograph 16 taken by Eileen Hileman on March 15, 2000, at Glover Middle School, Spokane, Washington. Photograph 16 shows a Westinghouse Transformer, serial number 57B34793, in room 124. There was no indication as to the type of dielectric fluid on the nameplate. The transformer was not marked with a PCB label (photograph 16). Mr. Brad Wolfrum claims that this type of transformer is air cooled and dry because of vents near the top but could not produce paperwork from the manufacturer confirming that. The configuration diagram normally available to make the determination was not on the nameplate.

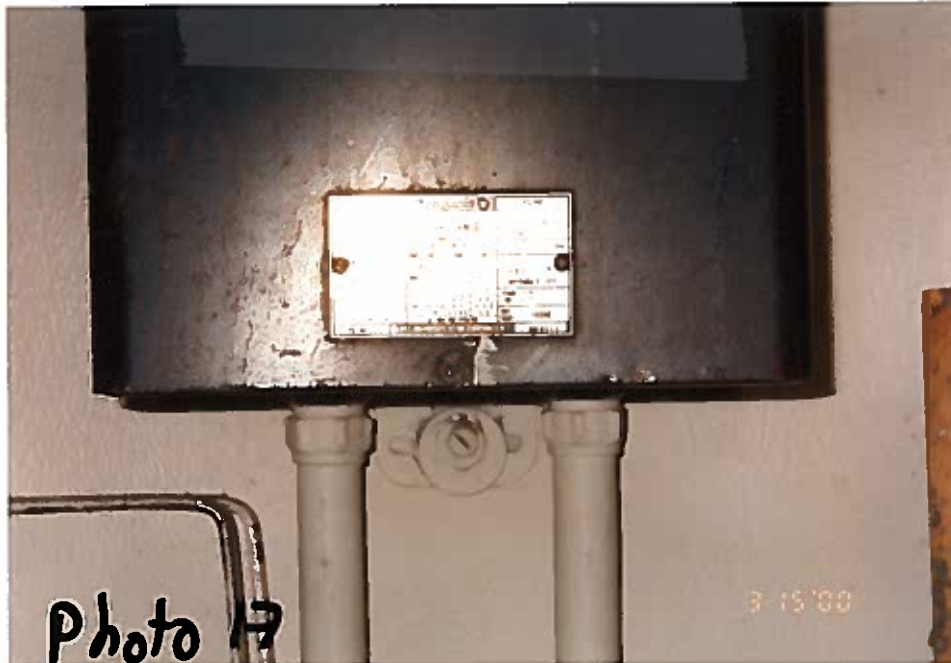
Photograph 17 taken by Eileen Hileman on March 15, 2000, at Glover Middle School, Spokane, Washington. Photograph 17 shows a Westinghouse wall mounted transformers (approximately 11 X 9 inches), 60 cycles, 480 volts, 5 KVA, style 3238701A18 in Room 137. There was no indication on the nameplate as to the type of dielectric fluid contained in the transformer. The transformer was not marked with a PCB label.

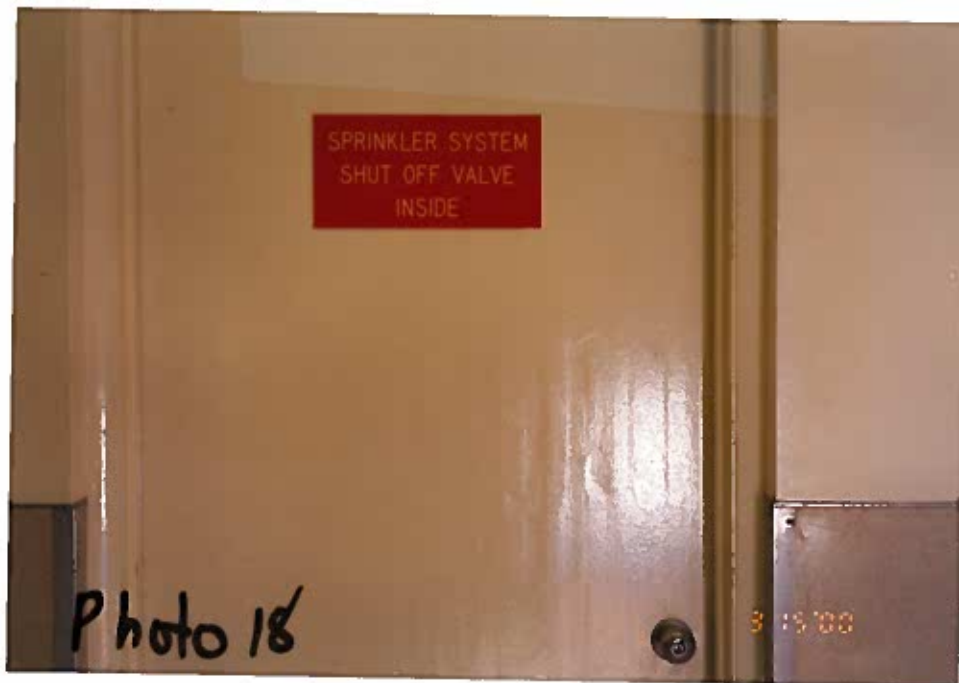
Photograph 18 taken by Eileen Hileman on March 15, 2000, at Glover Middle School, Spokane, Washington. Photograph 18 shows the entrance to the Room 137 was not marked with a PCB label.

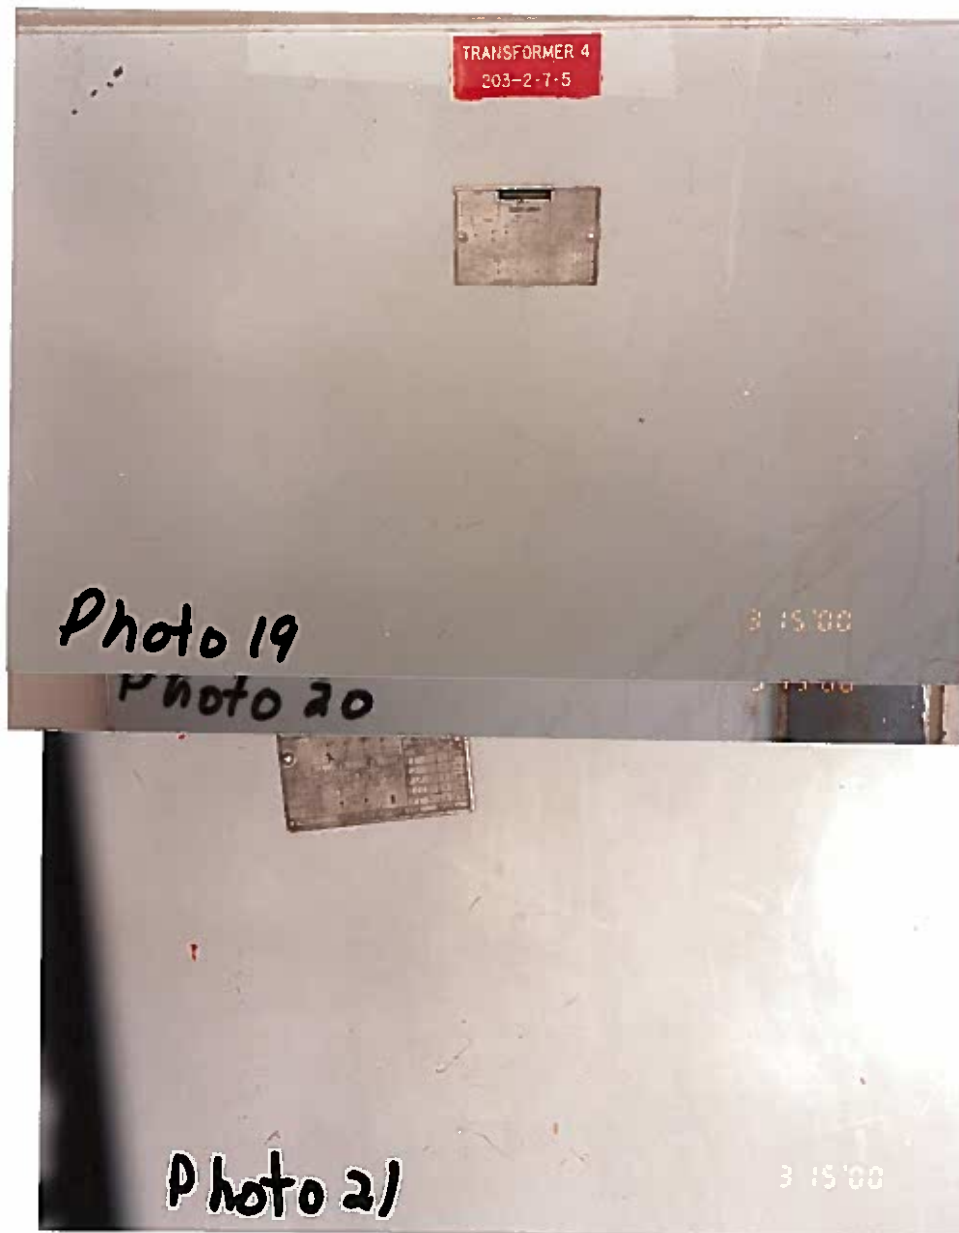
Photographs 19 & 20 taken by Eileen Hileman on March 15, 2000, at Glover Middle School, Spokane, Washington. Photographs 19 & 20 shows the second transformer housed in Room 137. The second transformer was also a Westinghouse, serial number 57K9922, 150 KVA, 480 volts, 3 phase, style 234A201G07, 60 cycles. There was no indication on the nameplate as to the dielectric fluid, however the transformer was vented and possibly could be a dry-type air-cooled. The transformer was not marked with a PCB label.

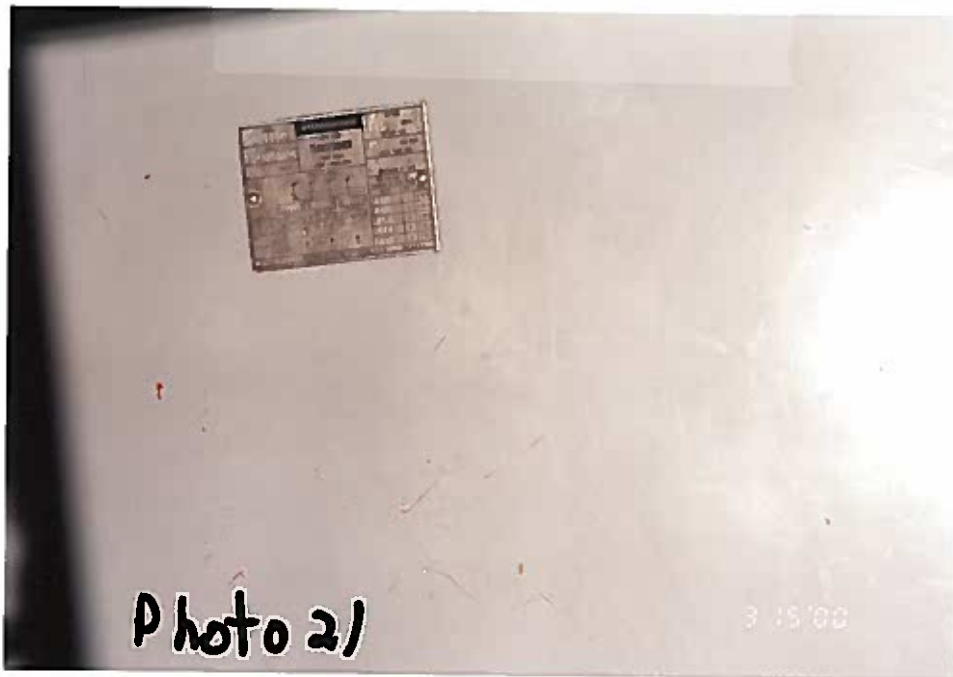
Room 144 also contained a Westinghouse transformer, serial number 58811805, style 2344A201G04, 480 volts, 45 KVA, 3 phase transformer. There was no indication on the nameplate as to the type of dielectric fluid in the transformer. The District claims the transformer is dry because of vents on the upper portion of the transformer but could provide no manufacture information to support the claim. The nameplate did not state "dry -type". The transformer was not marked with a PCB label (photograph 21). Room 144 also contained a Square D, 3 phase, dry-type transformer, 45 KVA, style number 33-749-17212-082. The door to room 144 was not marked with a PCB label (photograph 22).

Photograph 21 taken by Eileen Hileman on March 15, 2000, at Glover Middle School, Spokane, Washington. Photograph 21 shows a Westinghouse transformer, serial number 58811805, style 2344A201G04, 480 volts, 45 KVA, 3 phase transformer in Room 144. There was no indication on the nameplate as to the type of dielectric fluid in the transformer. The District claims the transformer is dry because of vents on the upper portion of the transformer. The transformer was not marked with a PCB label.

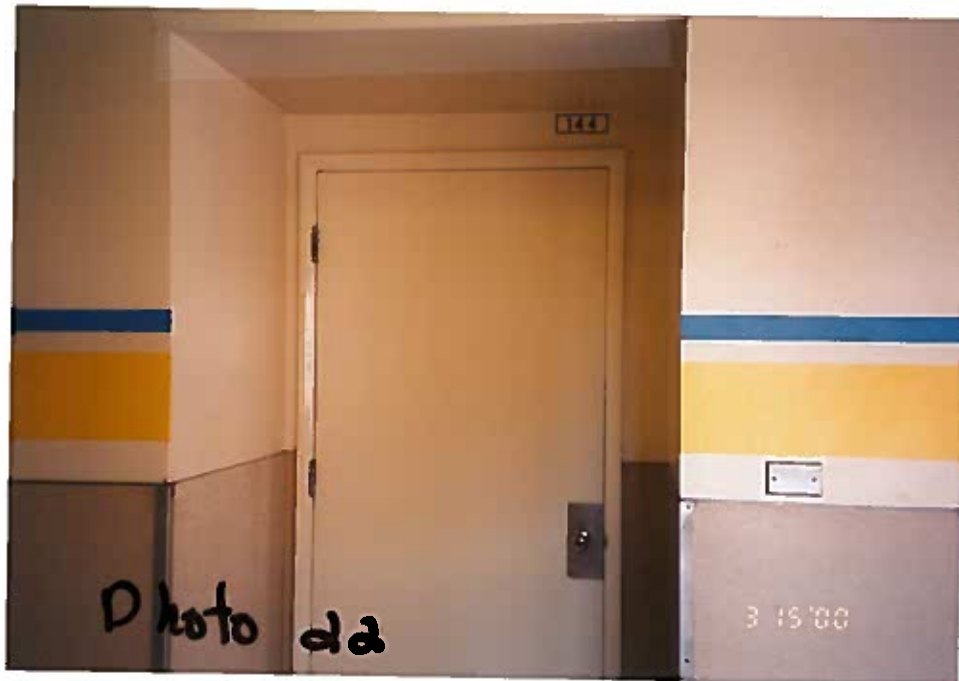
Photograph 22 taken by Eileen Hileman on March 15, 2000, at Glover Middle School, Spokane, Washington. Photograph 22 shows the door to Room 144 was not marked with PCB label.

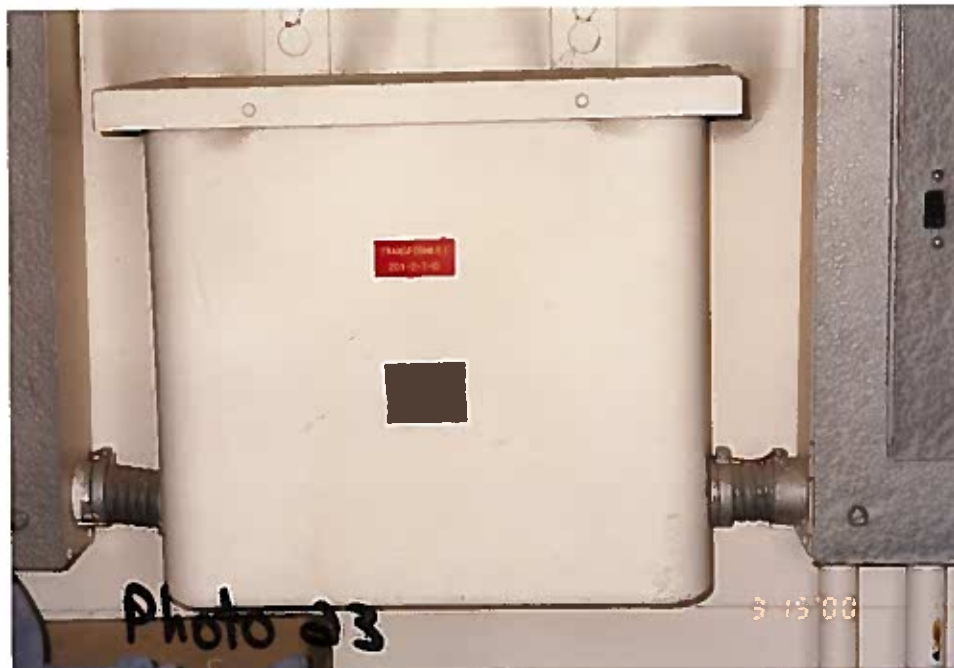
Room 178 contained two transformers. The first transformer was a Westinghouse, 3 phase, 480 volts, 30 KVA, serial number 234A201G03. There was no indication as to the type of dielectric fluid contained in the transformer. The transformer was not marked with a PCB label (photograph 23). The second transformer in room 178, was a Square D, 3 phase, dry-type general transformer. The entrance to room 178 was not marked with a PCB label (photograph 24).

Photograph 23 taken by Eileen Hileman on March 15, 2000, at Glover Middle School, Spokane, Washington. Photograph 23 shows a Westinghouse, 3 phase, 480 volts, 30 KVA, serial number 234A201G03 in Room 178. There was no indication as to the type of dielectric fluid contained in the transformer. The transformer was not marked with a PCB label.

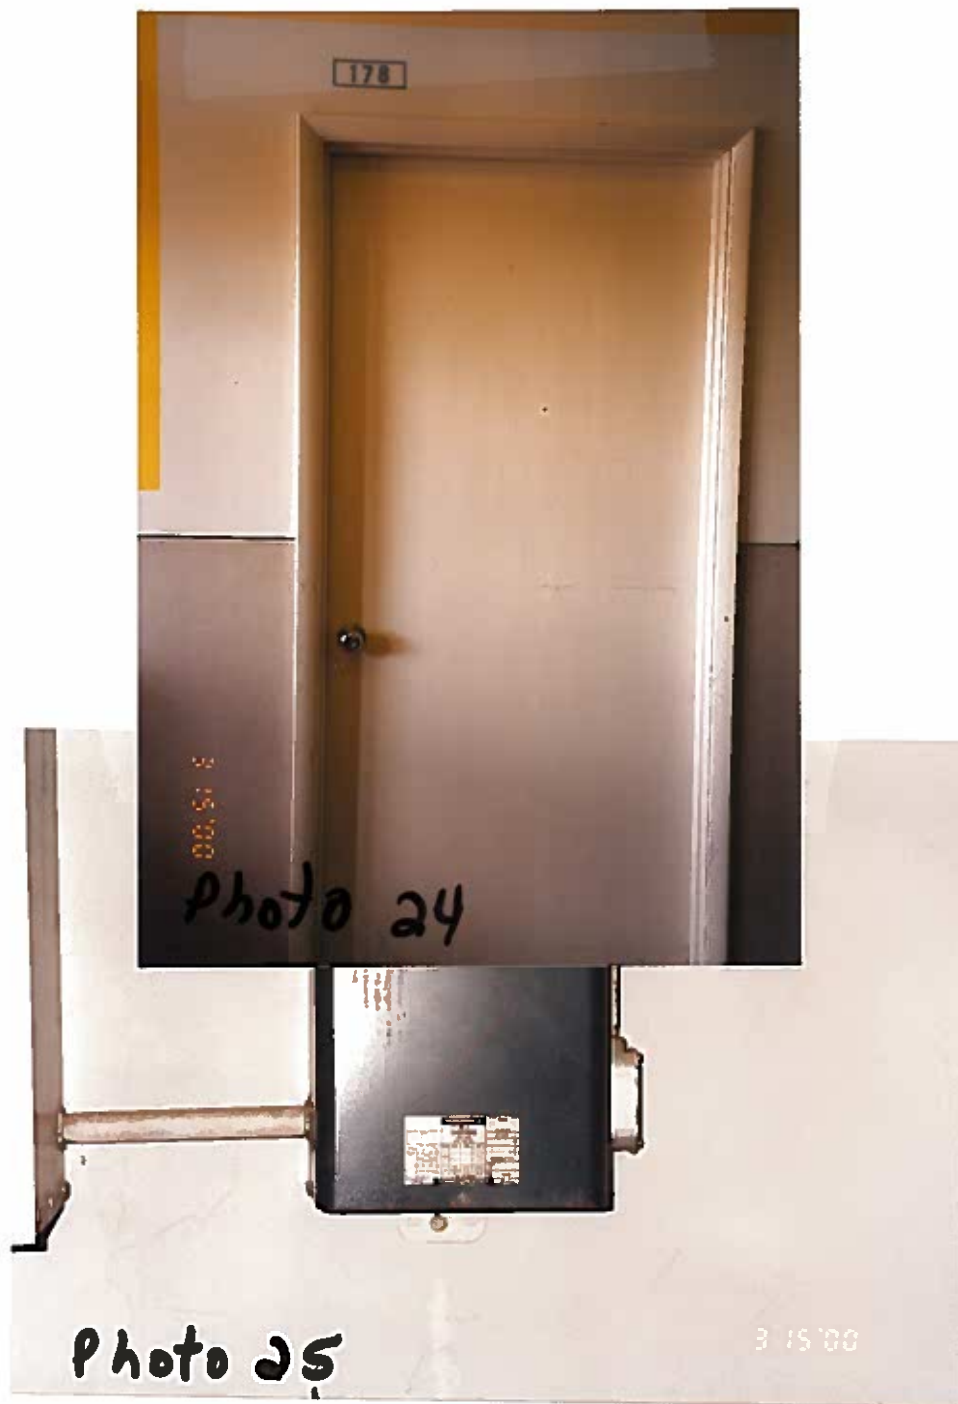
Photograph 24 taken by Eileen Hileman on March 15, 2000, at Glover Middle School, Spokane, Washington. Photograph 24 shows the entrance to room 178 was not marked with a PCB label.

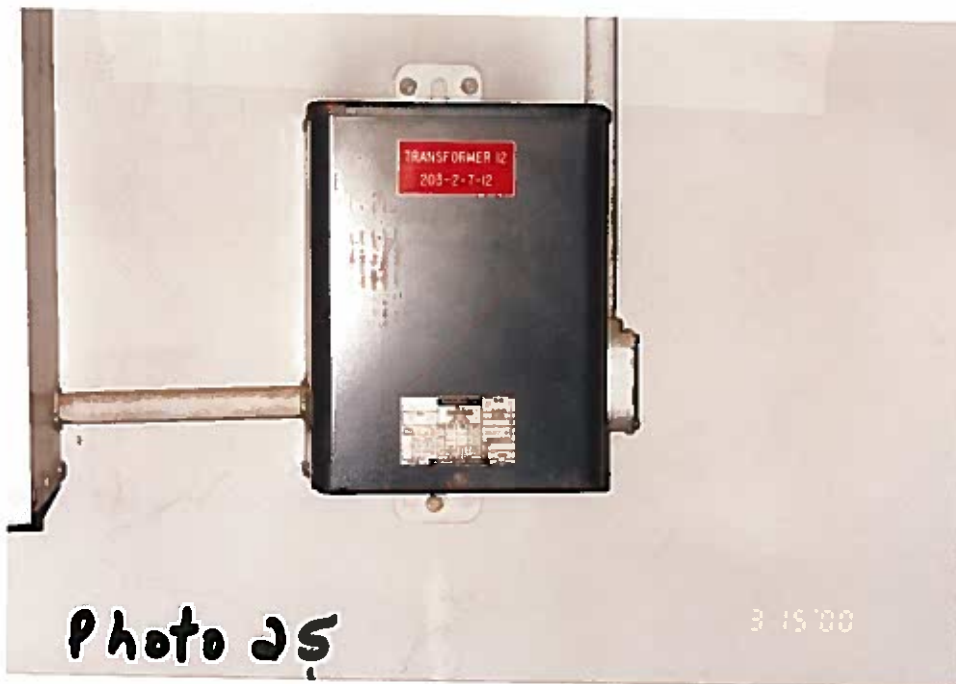
In boiler room A, there were two transformers. The first transformer was a small (7.5 X 10 inches) Westinghouse wall mounted transformer, Type EP, single phase, style 323B701A17, 480 volts, 60 cycles, 3 KVA. There was no indication on the nameplate as to the type of dielectric fluid. The transformer was not marked with a PCB label (photograph 25). The second transformer was a Westinghouse, 3 phase, 480 volts, 30 KVA, 60 cycles, serial number 58B17725 (photographs 26 and 27). The transformer was surrounded by cardboard, wood, and other materials. The entrance to the boiler room was not marked with a PCB label (photograph 28).

Photograph 25 taken by Eileen Hileman on March 15, 2000, at Glover Middle School, Spokane, Washington. Photograph 25 shows a small (7.5 X 10 inches) Westinghouse wall mounted transformer, Type EP, single phase, style 323B701A17, 480 volts, 60 cycles, 3 KVA located in Boiler Room A. There was no indication on the nameplate as to the type of dielectric fluid. The transformer was not marked with a PCB label.

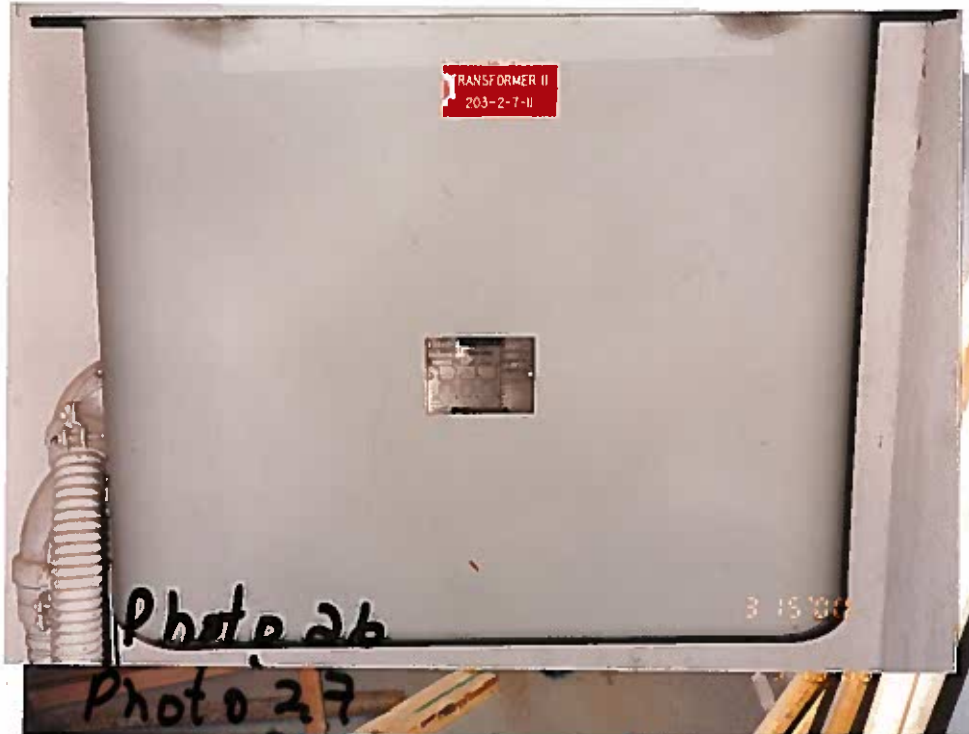
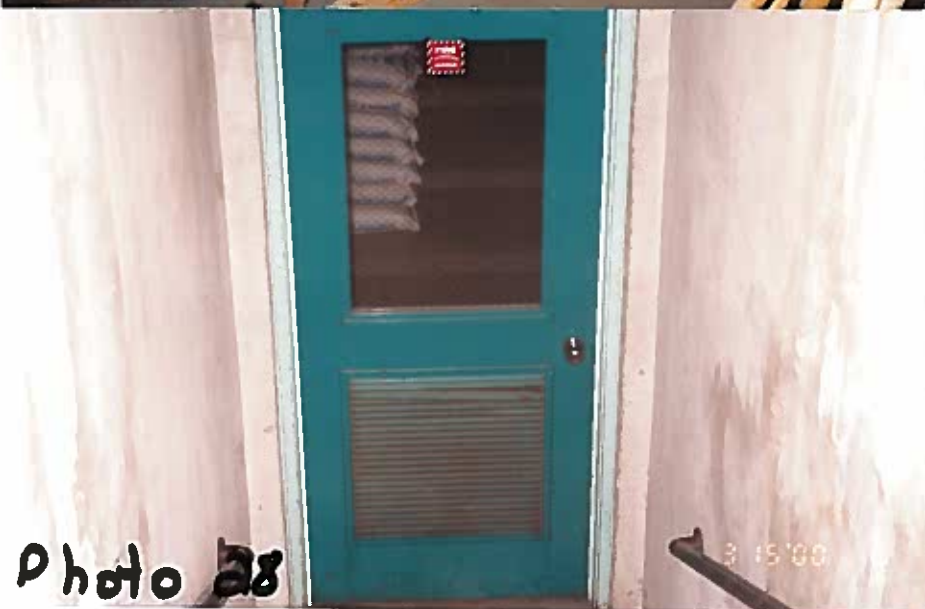
Photographs 26 & 27 taken by Eileen Hileman on March 15, 2000, at Glover Middle School, Spokane, Washington. Photographs 26 & 27 shows the second transformer in Boiler Room A was a Westinghouse, 3 phase, 480 volts, 30 KVA, 60 cycles, serial number 58B17725. There was no indication on the nameplate as to the type of dielectric fluid. The transformer was not marked with a PCB label. The transformer was surrounded by cardboard, wood, and other materials.

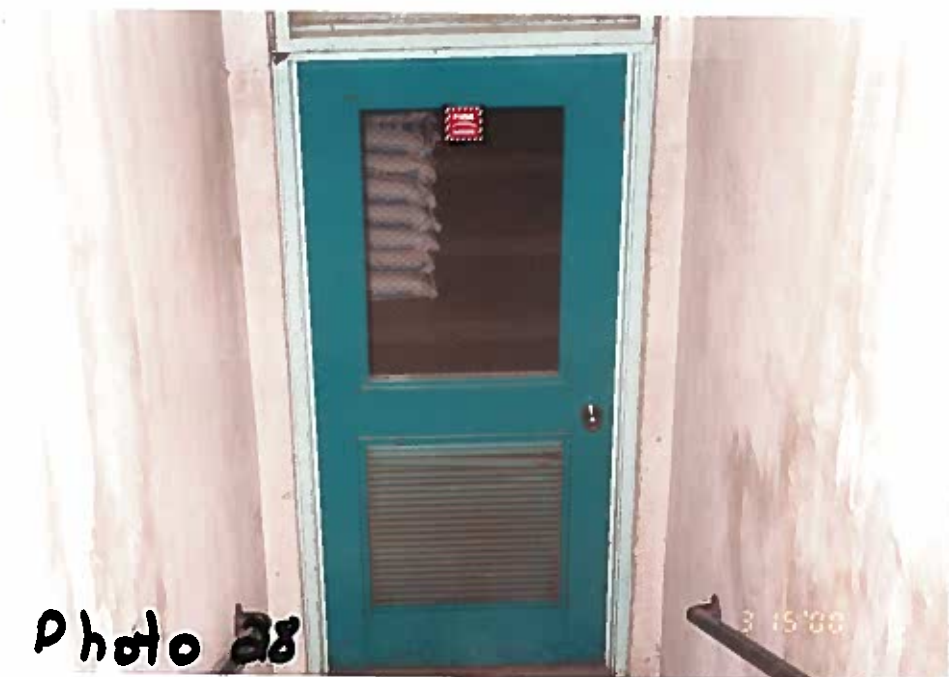
Photograph 28 taken by Eileen Hileman on March 15, 2000, at Glover Middle School, Spokane, Washington. Photograph 28 shows the entrance to the Boiler room was not marked with a PCB label.

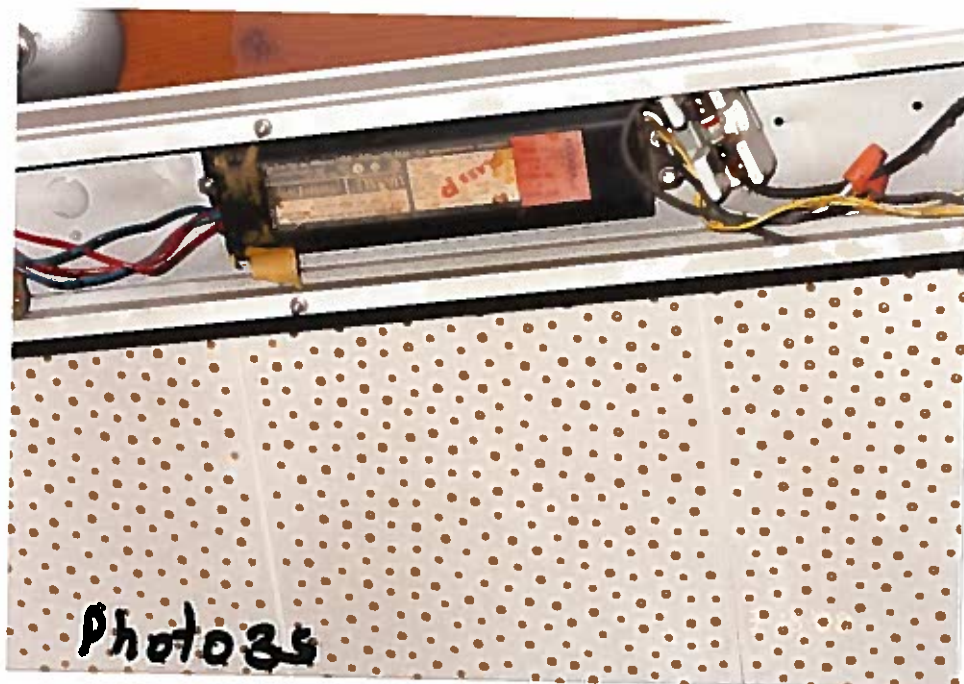
Outside room 158 we observed a broken light cover whose internal surface showed evidence of staining (photograph 32). Mr. McCartney donned protective gloves and removed the light cover. There was also a tar-like substance on the internal surface of the ballast cover (photograph 33). The capacitor nameplate contained no information as to PCB content nor did have a manufacture date. There was a tar-like substance on the surface of the ballast capacitor (photographs 34 and 35).

Photographs 34 & 35 taken by Eileen Hileman on March 15, 2000, at Glover Middle School, Spokane, Washington. Photographs 34 & 35 show the capacitor nameplate contained no information as to PCB content nor did have a manufacture date. There was a tar-like substance on the surface of the ballast capacitor.

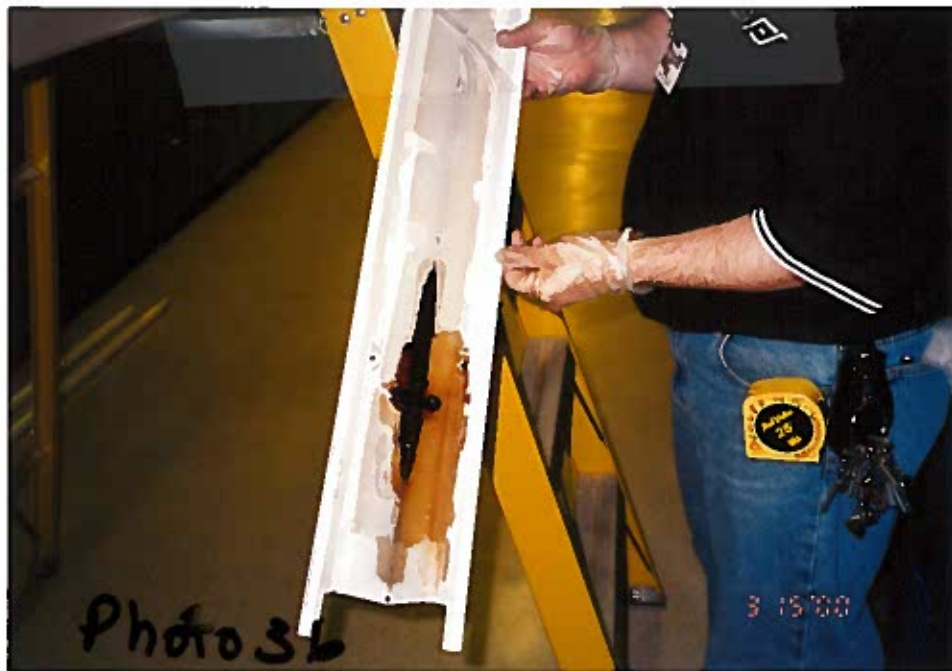
In the library, we examined a fluorescent light fixture. Mr. McCartney donned protective gloves and removed the light cover. The interior of the ballast cover contained a tar-like substance (photograph 36). The ballast capacitor was an Advance, class P, type 1, non-PCB capacitor which was intact and non-leaking (photograph 37). The tar-like substances covering the light cover and interior of the ballast were from the previous capacitor. District Project Officer Leandra Thompson, who was present representing Mr. Madsen and is responsible for some portion of management of the District's PCB program, could not tell us what type of leaking capacitor had been removed from the ballast, when it had been removed or why during the removal the leaks had not been cleaned from the internal and external surfaces. According to Ms. Thompson, the district does not keep records of these events nor require cleanup prior to replacement of ballasts.

Photograph 36 taken by Eileen Hileman on March 15, 2000, at Glover Middle School, Spokane, Washington. Photograph 36 shows the interior of a light ballast in Library. The interior of the ballast cover contained a tar-like substance.

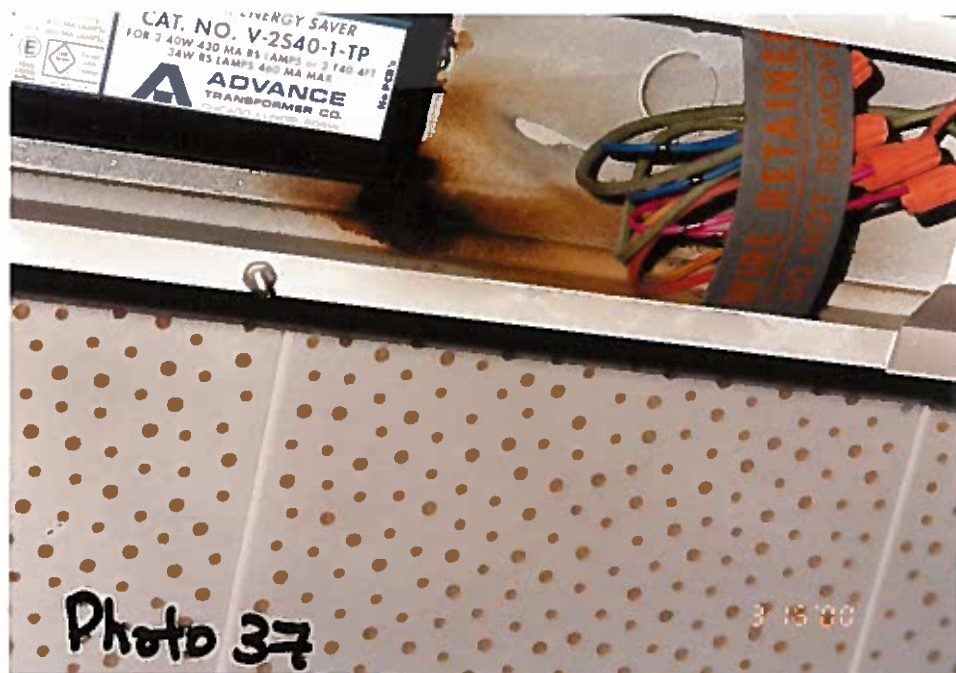
Photograph 37 taken by Eileen Hileman on March 15, 2000, at Glover Middle School, Spokane, Washington. Photograph 37 shows that the ballast capacitor examined in the Library was an Advance, class P, type 1, non-PCB capacitor which was intact and non-leaking. Photograph 37 also shows the tar-like substance within the internal surface of the ballast.

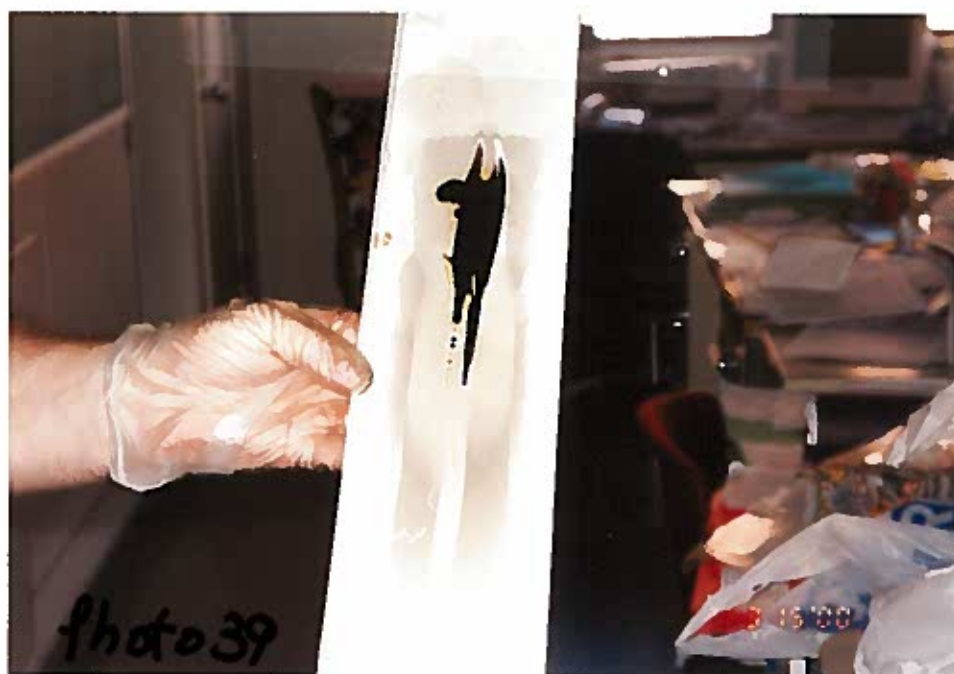
In room 149 we observed a leaking ballast with a tar like substance on the internal surface of the ballast cover (photograph 39 (note photo 38 was a mis-shoot)). The capacitor within the ballast was a Universal Hi-Output Rapid Start, 277 volts, 60 cycles. There was no indication as to the PCB content of the capacitor nor was a manufacture date on the nameplate (photograph 40).

Photograph 40 taken by Eileen Hileman on March 15, 2000, at Glover Middle School, Spokane, Washington. Photograph 40 shows the capacitor within the ballast in Room 149 was a Universal Hi-Output Rapid Start, 277 volts, 60 cycles. There was no indication as to the PCB content of the capacitor nor was a manufacture date on the nameplate.

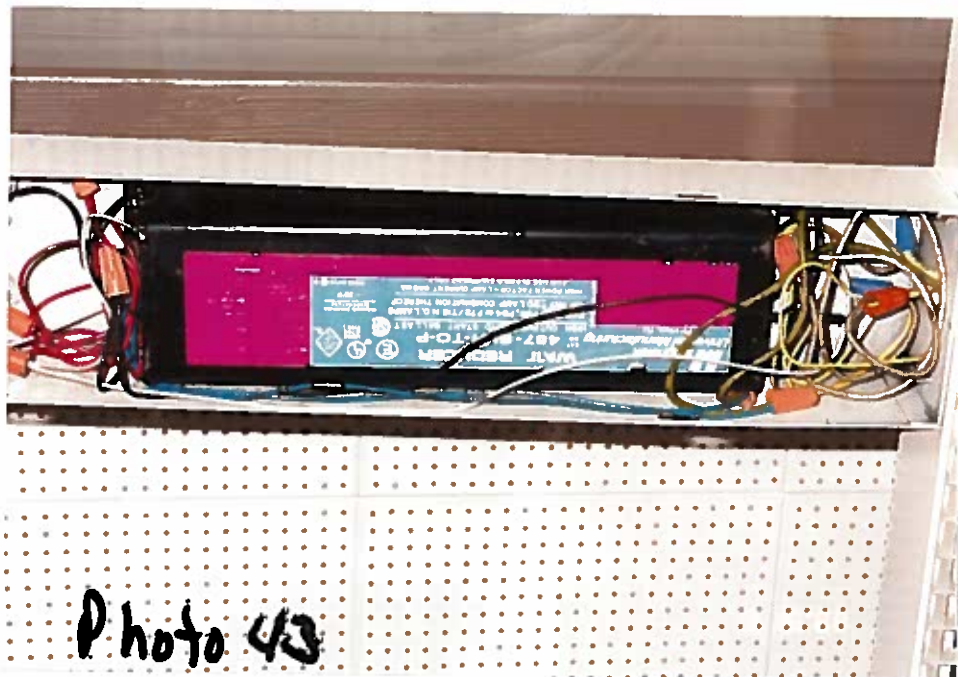
Photograph 43 taken by Eileen Hileman on March 15, 2000, at Glover Middle School, Spokane, Washington. Photograph 43 shows the capacitor referenced in photos 41 & 42 above was a Magnetek, 27 volts, 60 hertz, class P, non-PCB capacitor. It was not leaking at the time of the inspection. It appears that the tar-like substance came from the previous capacitor and the leaks were not cleaned up when the capacitor was changed out.

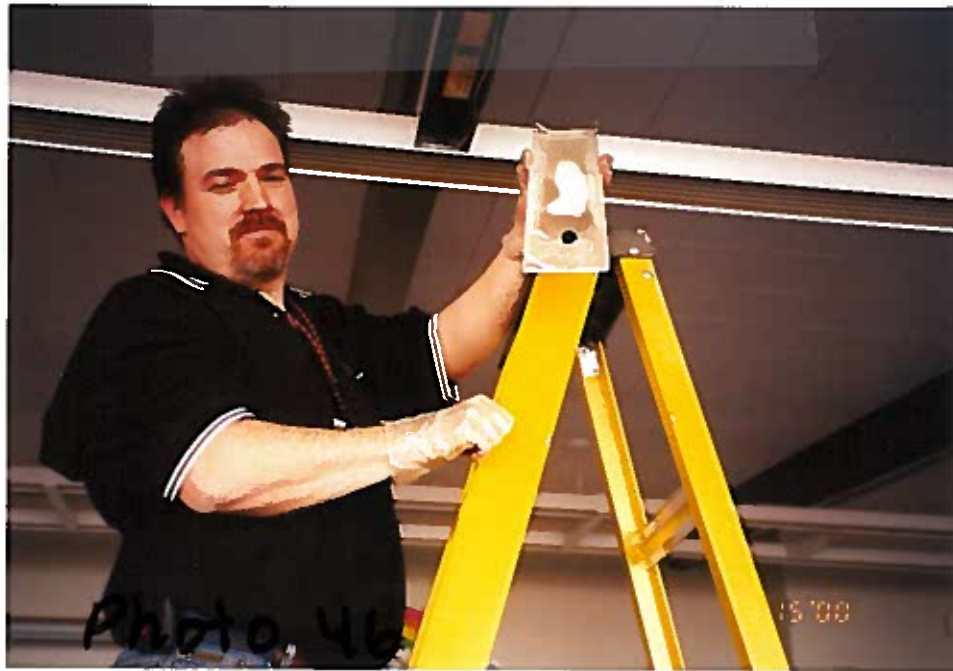
The next ballast in Room 149 was also leaking. There was a tar-like substance on the interior surface of the ballast cover (photograph 46). The capacitor was a GE rapid start that appeared to be very old. There was no indication on the nameplate as to PCB content and nor was there a manufacture date on the nameplate (photograph 47). There was a tar like substance on the external surface of the capacitor. Student's desks were directly beneath this ballast.

Photograph 46 taken by Eileen Hileman on March 15, 2000, at Glover Middle School, Spokane, Washington. Photograph 46 show there was a tar-like substance on the interior surface of the next ballast cover examined in Room 149.

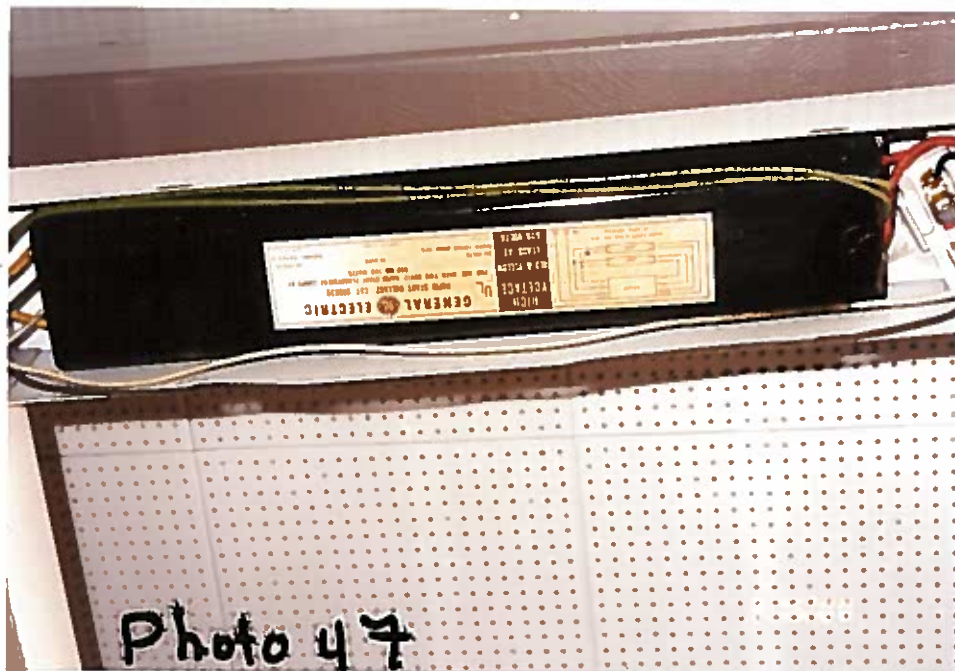
Photograph 47 taken by Eileen Hileman on March 15, 2000, at Glover Middle School, Spokane, Washington. Photograph 47 shows the capacitor was a GE rapid start that appeared to be very old. There was no indication on the nameplate as to PCB content and nor was there a manufacture date on the nameplate. There was a tar like substance on the external surface of the capacitor. Student's desks were directly beneath this ballast.
